# COMPLETION REPORT

## TRANSDUCER CALIBRATION PLATFORM (TCP) MOORING

NAVAL UNDERWATER SYSTEMS CENTER,  
SENECA LAKE DETACHMENT  
DRESDEN, NEW YORK

FPO-1-83 (33)

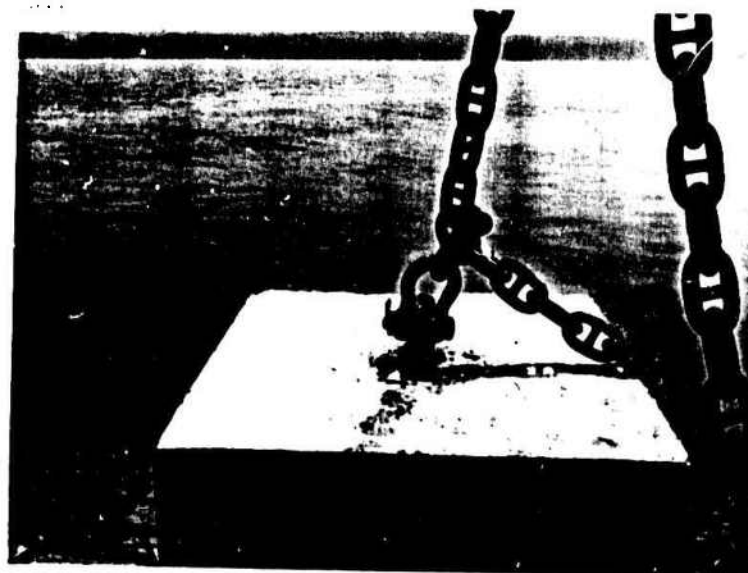
**FIGURE 15**

The sinker was connected on the last half-shot of chain in each mooring leg, one link in from the last full shot (see Figures 15 and 16). The connection was made with a 2 1/2-inch safety shackle back-to-back with a sinker shackle as shown in Detail A of the "as-built" drawing. The nut on the safety shackle was welded in place, and the locking pin on the sinker shackle was peened over. The sinker was lowered to the bottom, then raised 10 feet while a strain was taken on the keedge anchors or pulling lines to ensure that the chain was taut. The sinker was lowered again after all slack was taken out of the chain.

**BACK-TO-BACK 2 1/2 INCH SAFETY SHACKLE  
AND SINKER SHACKLE CONNECTION**

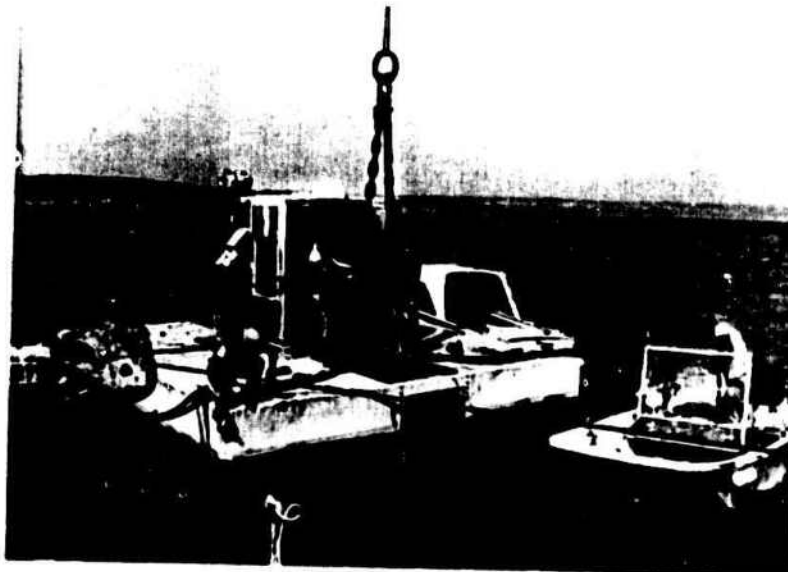
**FIGURE 32**

To secure the transformer float between the northwest and northeast buoys, the CHESDIV Project Manager instructed the contractor to fit a bridle to the padeyes at the corners of each end of the float (see Figures 32 and 33). The bridle, consisting of 1 1/4-inch DI-Lok chain with associated fittings, was connected to each buoy's mooring line as shown in Detail H of the "as-built" drawing.

**CONNECTING EAST 1 1/4 INCH BALDT  
DI-LOK CHAIN BRIDGE ON THE  
TRANSFORMER FLOAT**

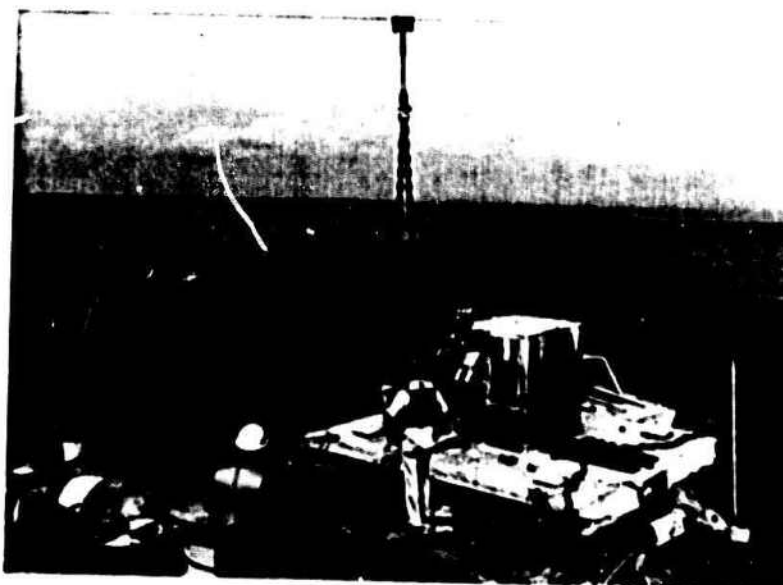
**FIGURE 33**

**CONNECTING WEST 1 1/4 INCH BALDT  
DI-LOK CHAIN BRIDGE ON THE  
TRANSFORMER FLOAT**
